STORMWATER COMPLIANCE INSPECTION REPORT				WADOE Stormwater
	State of Washington Department of Ecology 3190 – 160 th Avenue SE, Bellevue, WA 98008-5452				Phone: (425) 649-7000 FAX: (425) 649-7098
Section A: General Data					
Inspection Date 11/20/2018	NPDES Permit # WAR001134	County King	Receiving Waters Duwamish River	Inspector Ben Billick & Alex White	Facility Type Industrial
Discharges to: Surface Water <input checked="" type="checkbox"/> Ground Water <input type="checkbox"/>				UNANNOUNCED Inspection	
Section B: Facility Data					
Name and Location of Site Inspected Ardagh Glass Inc. 5801 E Marginal Way S Seattle, WA 98134		Lat & Long Lat: 47.55197012826 Long: -122.339350957719		Entry Time 10:30 AM	Permit Effective Date 01/01/2015
				Exit Time 2:00 PM	Permit Expiration Date 12/31/2019
On-Site Representative(s): Name(s)/Title(s)/Contact number(s) or E-mail Lana Getubig, EH&S Manager (206) 768-6221; lana.r.getubig@ardaghgroup.com				Additional Participants:

PHOTO ADDENDUM - ARDAGH GLASS 11/20/18

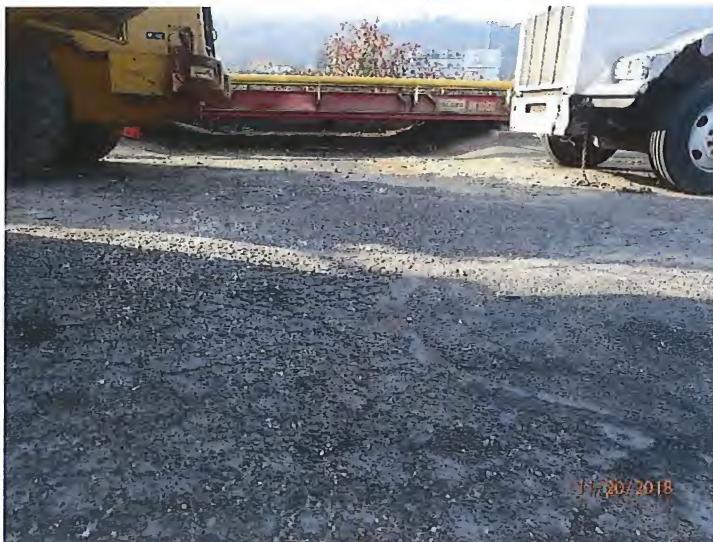
- The majority of the site is paved. Alligator cracking and other pavement damage was observed throughout the site. The poor pavement condition likely reduces sweeping efficacy and contributes to sediment and debris control issues on-site.

001 DESCRIPTION: ALLIGATOR CRACKING OF PAVEMENT.

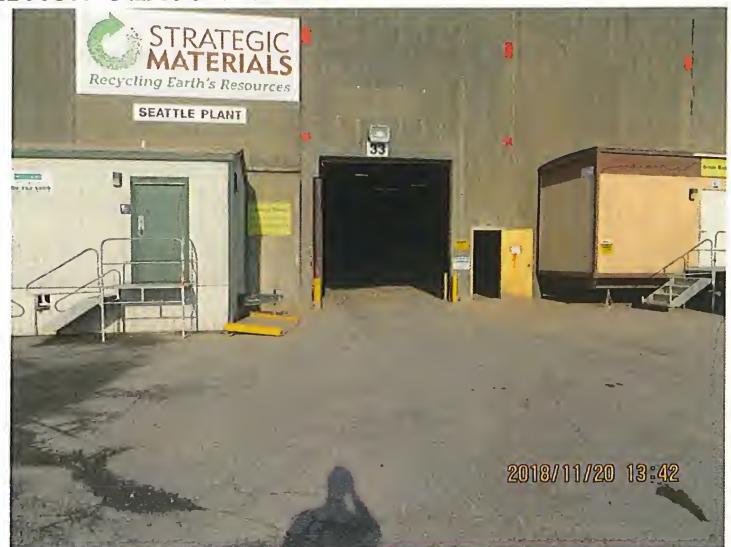
- Vacuum sweeping of the site is conducted on a weekly basis. Sweeping is conducted by both a street sweeping contractor and by using small, ride-on industrial shop sweepers that are owned by the facility. Despite sweeping activities, significant accumulation of sediment, dust, and particulate debris was observed in multiple locations on-site. Sediment and debris accumulation was particularly high in the drainage basin for outfall 3. The majority of industrial activities in this drainage basin are conducted by Strategic Materials, a tenant of Ardagh Glass that sorts and processes glass for recycling. Track out of fine debris particles from inside Strategic Materials' operations building onto the outside pavement was observed. Piles of debris were also observed on the pavement outside of the Strategic Materials building. Additional areas of heavy sediment and debris accumulation were observed near the bag houses in drainage basin 1 and around large objects (e.g. dumpsters) throughout the site that may not be easily accessed by the street sweepers. We discussed the need for improved sediment control with L. Getubig, as the BMPs currently employed do not provide all known, available, and reasonable methods of prevention, control, and treatment (AKART).

002 DESCRIPTION: TRACK OUT OF FINE DEBRIS FROM STRATEGIC MATERIALS BUILDING AND SMALL PILES OF DEBRIS OUTSIDE OF DOORS.

- Ardagh Glass is in violation of permit condition S10.C, failure to apply all known and reasonable methods of prevention, control, and treatment (AKART) for the management of sediment, dust, and particulate debris on-site. Within 30 calendar days of receipt of this report develop and implement a plan to better control sediment, dust, and particulate debris on-site. Ensure that the SWPPP is updated to reflect any changes in BMPs.

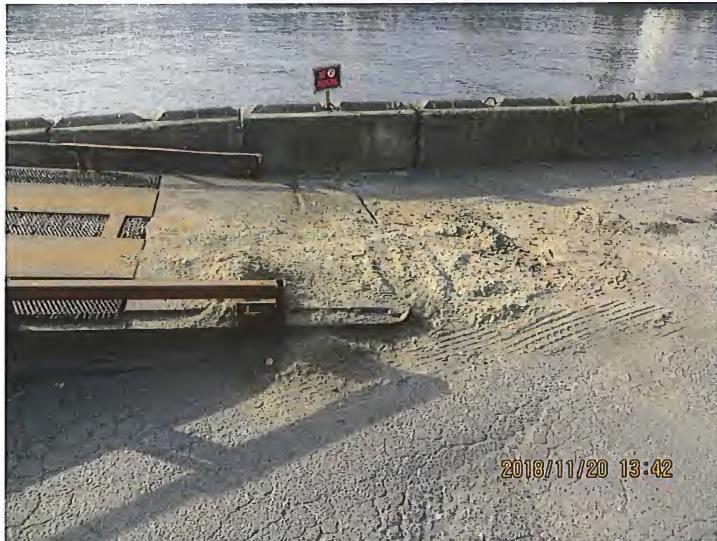
003 DESCRIPTION: PILE OF FINE DEBRIS ON PAVEMENT ALONG THE DUWAMISH RIVER IN DRAINAGE BASIN 3.

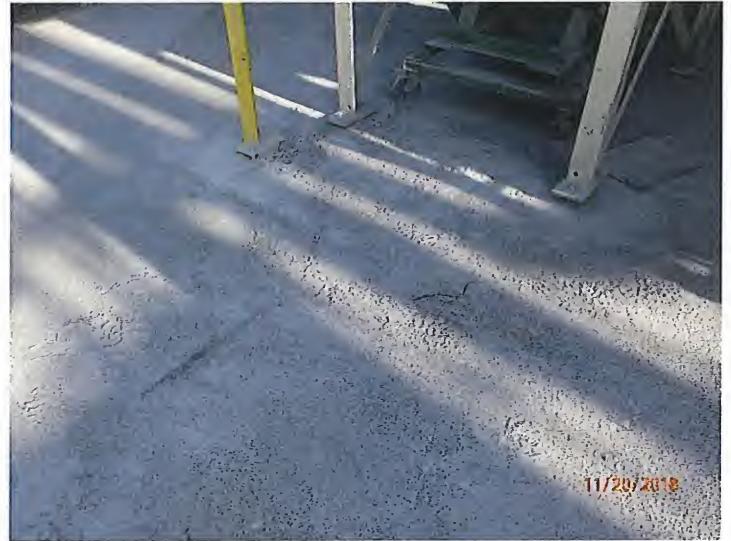
004 DESCRIPTION: HEAVY DUST ACCUMULATION ON GROUND AROUND BAG HOUSES IN DRAINAGE BASIN 1.

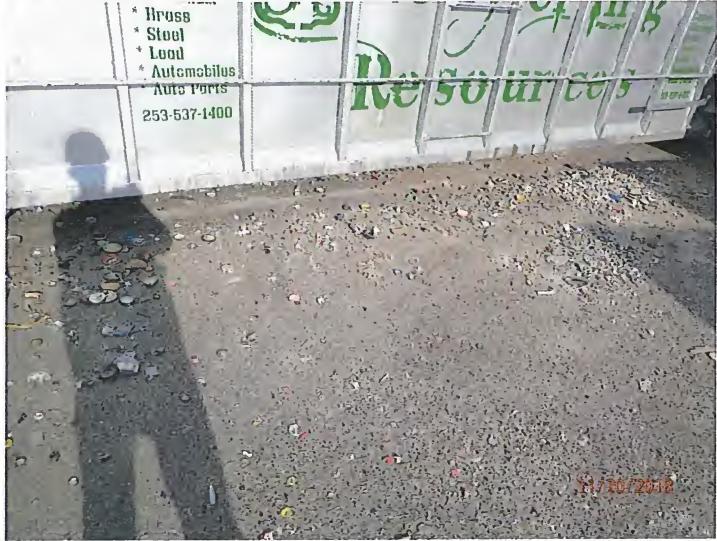
005 DESCRIPTION: DEBRIS AND SEDIMENT ACCUMULATION AT BASE OF DUMPSTER.

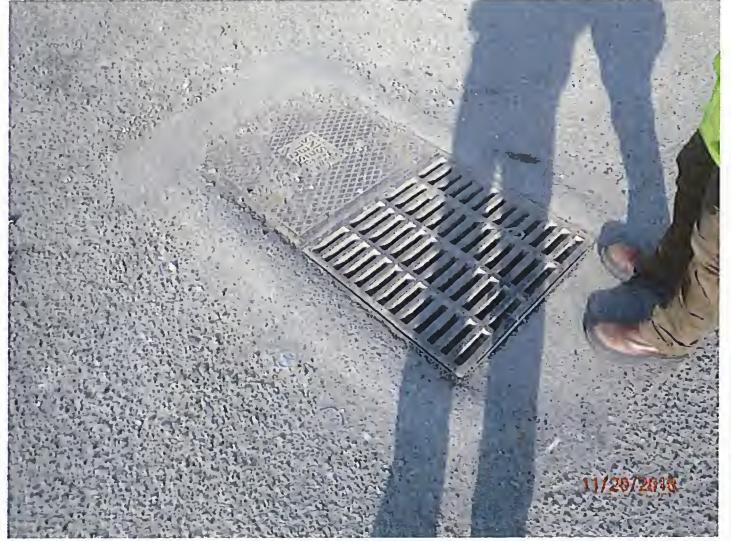
- All dumpsters are fitted with lids that are kept closed when not in use.
- Several of the catch basins on-site required maintenance to remove accumulated sediment and debris from the treatment media/filter inserts.

006 DESCRIPTION: TREATMENT CATCH BASIN IN DRAINAGE BASIN 3.

- **Ardagh Glass is in violation of permit condition S3.B.4.b.i.3, failure to maintain stormwater drainage/treatment BMPs.** Within 10 calendar days of receipt of this report, inspect all catch basin treatment BMPs, remove excess sediment and debris, and replace treatment media as necessary.

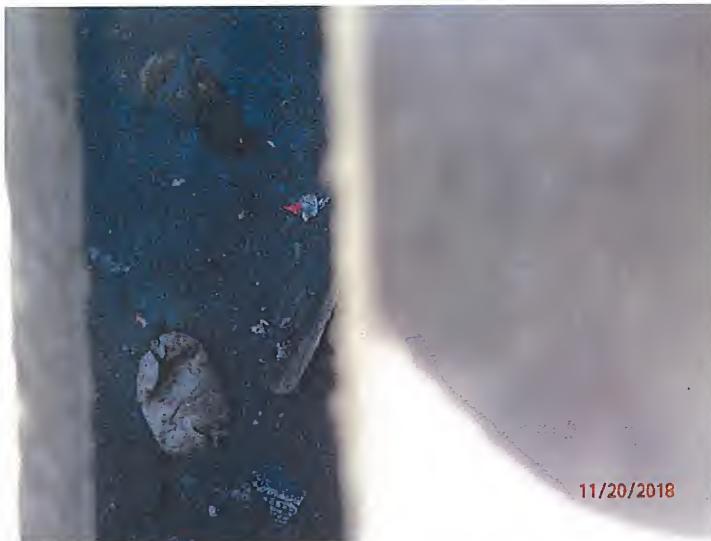
007 DESCRIPTION: HEAVY SEDIMENT AND DEBRIS ACCUMULATION ON TOP OF THE TREATMENT MEDIA INSIDE THE CATCH BASIN SHOWN IN PHOTO 006.

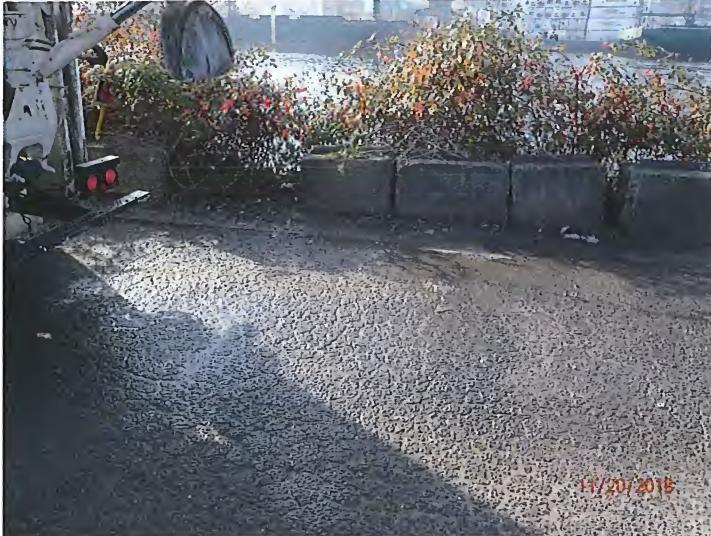
- A paving contractor was on-site performing concrete work during the inspection. We observed the operator of one of the concrete trucks washing out on-site in drainage basin 3, directly adjacent to the Duwamish River. The operator was attempting to collect the wash water in a five-gallon bucket, but much of it was spilling onto the ground. The operator stopped the washing activities when instructed to do so. Pavement staining that appeared to be from another concrete truck being washed out onto the ground was also observed in one location in drainage basin 2 during the inspection.

009 DESCRIPTION: CONCRETE WASHOUT WATER ON PAVEMENT ADJACENT TO THE RIVER. ALLIGATOR CRACKING ON PAVEMENT.

- **Ardagh Glass is in violation of permit condition S3.B.4.b.i.7.ii, failure to properly manage washwater.** Immediately ensure that all washing activities, including washout of concrete trucks, are conducted in areas where the washwater can be collected and properly disposed of. Washwater is considered a process water and cannot be

allowed to discharge to surface waters or the storm drainage system.

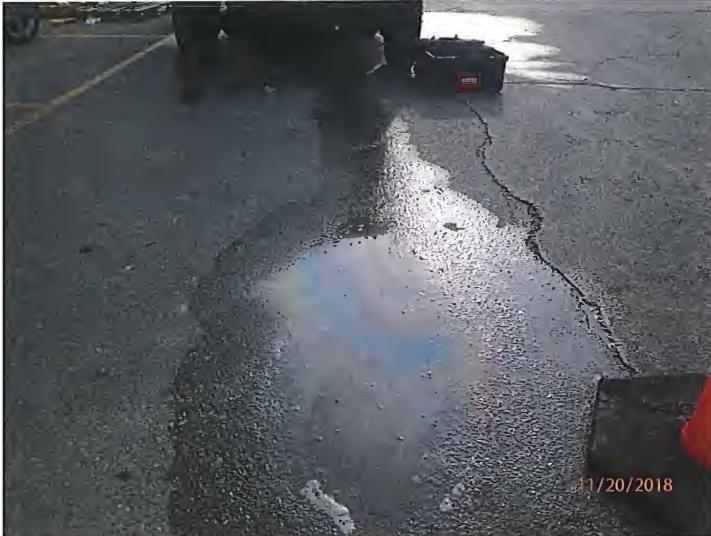
- A piece of heavy equipment and a contractor's truck were actively leaking fluid at the time of the inspection. No actions had yet been taken to contain or clean up the leaks when they were observed.

011 DESCRIPTION: SHEEN ON WATER FROM LEAKING CONTRACTOR TRUCK.

- **Ardagh Glass is in violation of permit condition S3.B.4.b.i.3.d, failure to immediately clean up spills and leaks.** Ensure that future spills and leaks are cleaned up immediately and that contaminated spill cleanup materials are properly disposed of. Ensure that appropriate staff are properly trained in the facility's procedures for identifying and responding to spills and leaks.

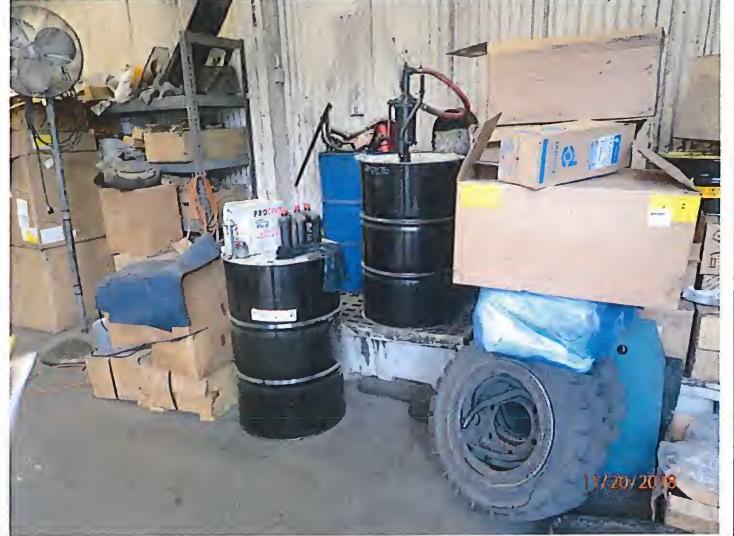
- Spill kits were stored in multiple locations on-site.
- The facility has an on-site maintenance shop for their equipment. The majority of liquid products in the shop were stored on a secondary containment pallet; however, one 55-gallon drum of oil and a few miscellaneous containers of automotive fluids did not have containment. The maintenance shop is relatively small and has a door that opens to the outside, so liquid spills outside of containment could reach the outside.

012 DESCRIPTION: 55-GALLON OIL DRUM OFF OF SECONDARY CONTAINMENT PALLET IN THE MAINTENANCE SHOP.

- In accordance with permit condition S3.B.4.b.i.4.a, ensure that containers of chemical liquids, fluids, and petroleum products kept in the maintenance shop are stored in secondary containment. Though these materials are stored inside, the small size of the shop and proximity to the outdoors creates a possibility that spills could reach the storm drainage system.
